CONSERVATION MANAGEMENT PLAN ADDENDUM 2010

**ST JOHN'S ANGLICAN CHURCH PRECINCT
MENANGLE ROAD
CAMDEN NSW 2570**

15 December 2010

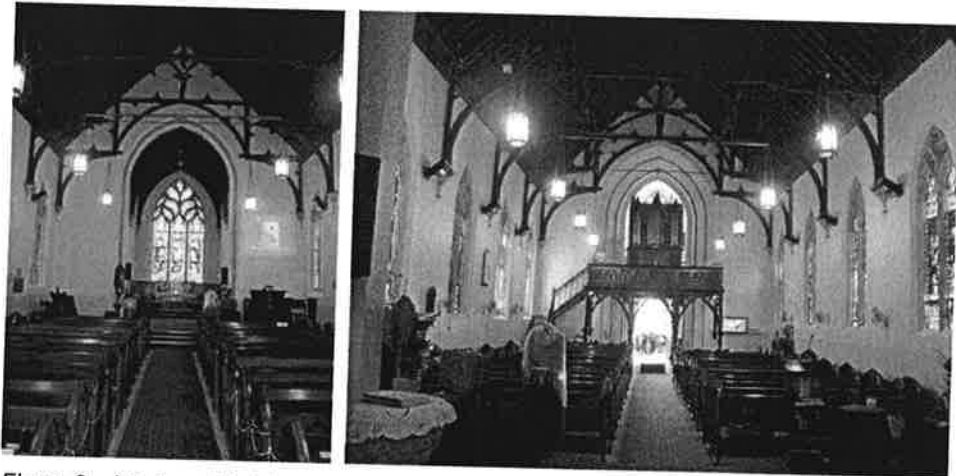
Figure 2 – Interior of St John's Anglican Church looking east to altar (left) and west to entry and organ in choir loft (right). The interior of the church has recently been painted using the paint schedule prepared by Clive Lucas, Stapleton & Partners (Source: NBRSPARTNERS, Oct 2010)

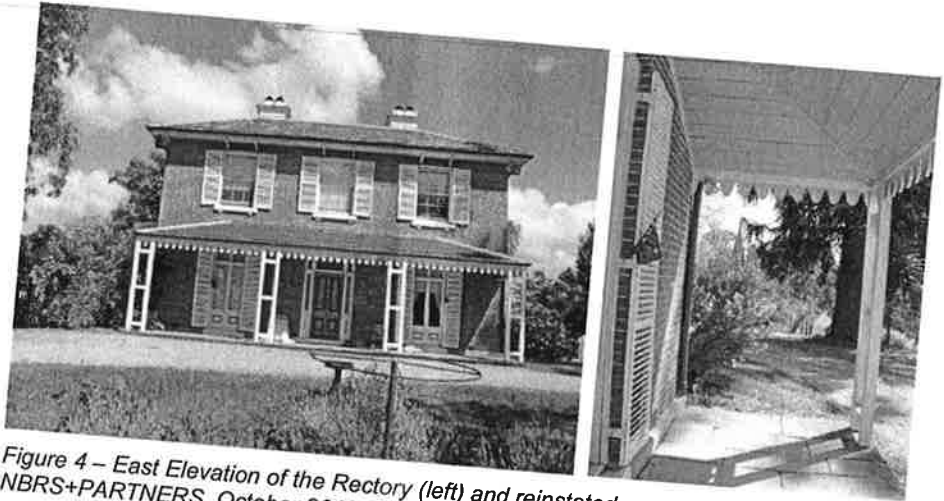
Figure 4 – East Elevation of the Rectory (left) and reinstated verandah (Source: NBRSPARTNERS, October 2010)

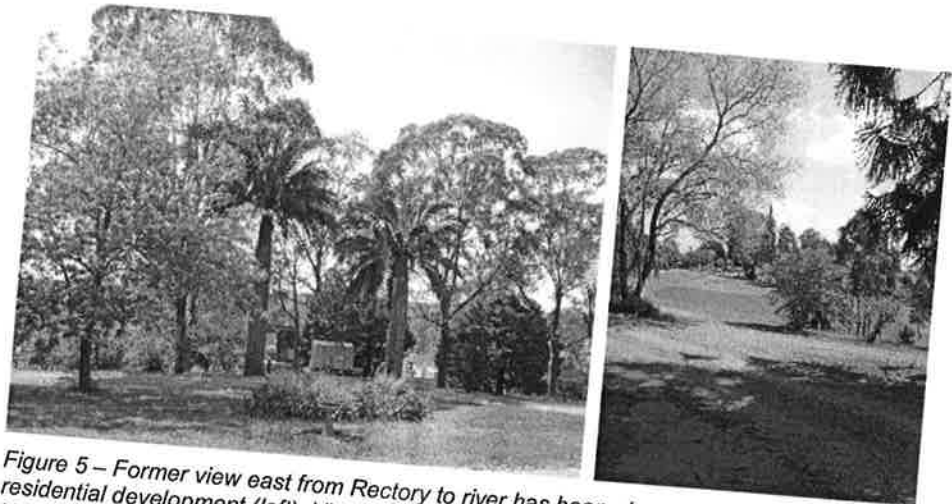
Figure 5 – Former view east from Rectory to river has been obscured by plantings and residential development (left). View north from the Rectory turning circle, across the Horse Paddock, to St John's Church (Source: NBRSPARTNERS, October 2010)

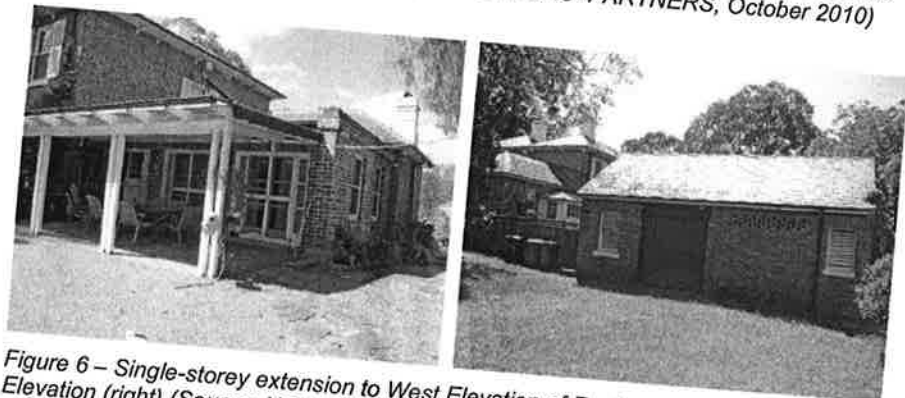
Figure 6 – Single-storey extension to West Elevation of Rectory (left) and Stables, West Elevation (right) (Source: NBRSPARTNERS, October 2010)

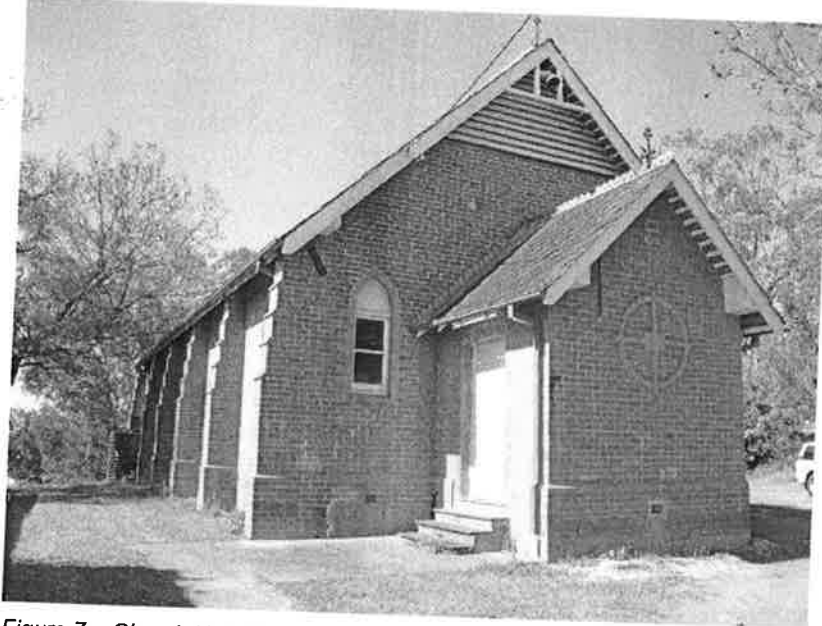
Figure 7 – Church Hall, North Elevation, facing onto Broughton Street (Source: NBRSPARTNERS, October 2010)

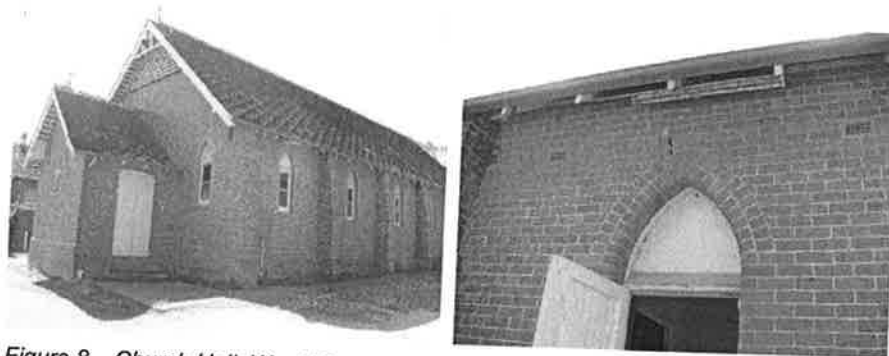
Figure 8 – Church Hall, West Elevation (left) and view of the western wall showing the cracking in the brickwork above the arched door entry (right). The structural cracking has been alleviated by connecting downpipe to water mains to reduce moisture affecting soil conditions under the building (Source: NBRSPARTNERS, October 2010)

- ***Policy 39: Preserve the form, materials and presentation of the Broughton Street Elevation to the Church Hall.***
- ***Policy 40: Preserve the open-planning of the interior of the church hall.***
- ***Policy 41: Monitor the structural cracking to the southern portion of the Church Hall. Continue to implement the corrective drainage works and consider the construction of French drains to the perimeter of the building.***

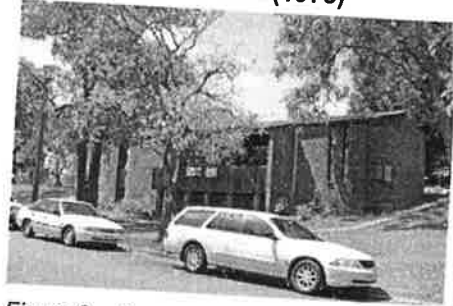
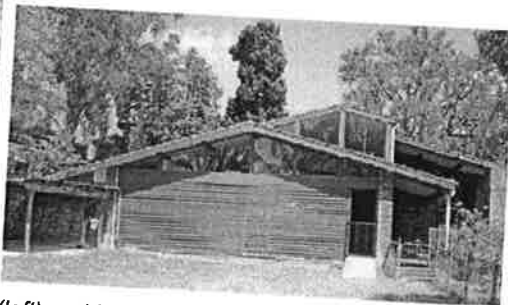
Figure 9 – Community Hall, West Elevation (left) and North Elevation (right) (Source: NBRSPARTNERS, Oct 2010)

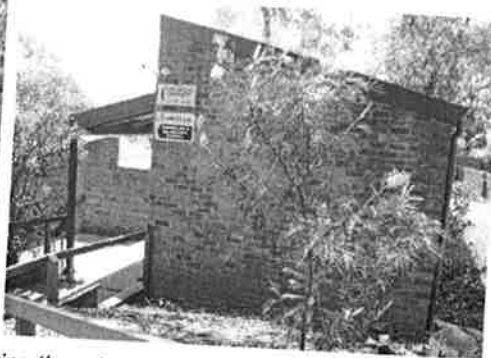
Figure 10 – View from Broughton Street showing the relationship between the Community Hall, and the Church (left). St John's Anglican Church Office (right) (Source: NBRSPARTNERS, Oct 2010)

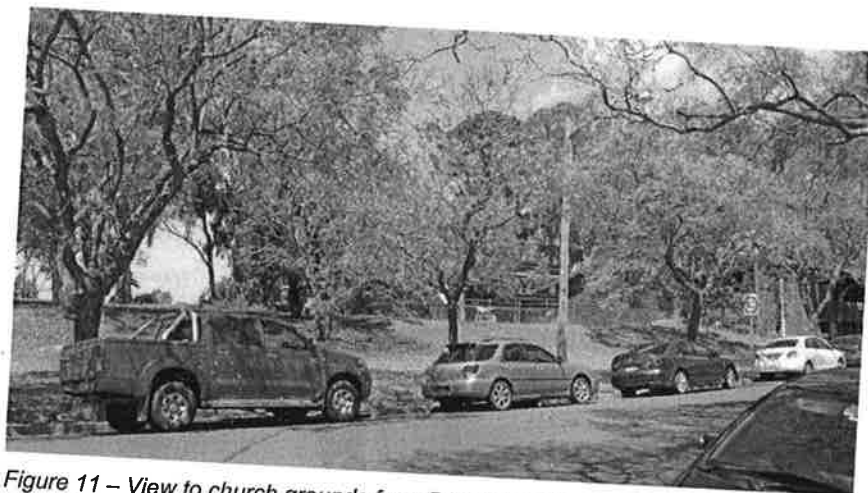
Figure 11 – View to church grounds from Broughton Street showing church obscured by Church hall (1973) and tree plantings (Source: NBRSPARTNERS, Oct 2010)

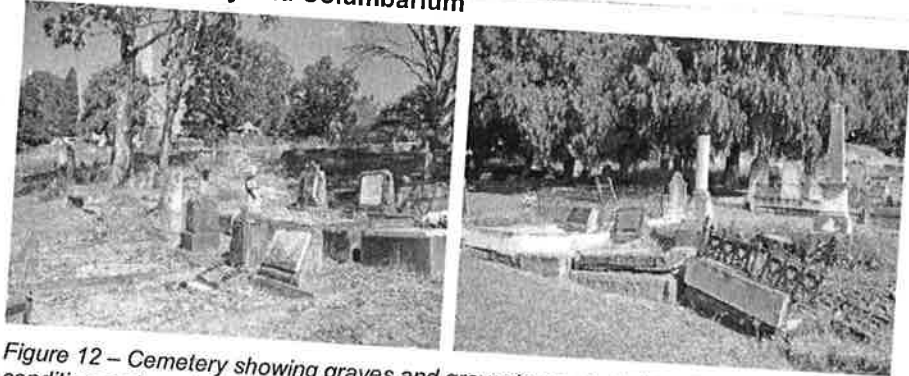
Figure 12 – Cemetery showing graves and gravestones, including some in ruinous condition and requiring conservation works (Source: NBRSPARTNERS, October 2010)

- ***Policy 46: Efforts should be made by the Parish Council to involve the local community in fundraising, maintenance and conservations works to the cemetery. This could include establishing a Cemetery 'Friends' group to work towards the protection, repair, research and interpretation of the cemetery.***
- ***Policy 47: A register and cemetery plan, based on original Church records, was developed and updated by a church committee in 2009. This register should be made available to the public. The Register should itemise required conservation works for each grave site.***

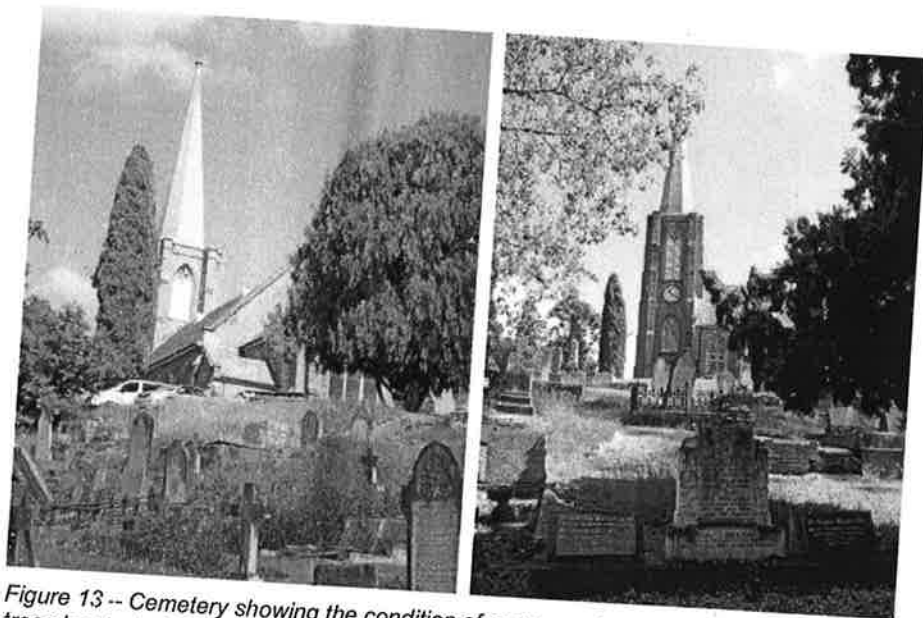
Figure 13 -- Cemetery showing the condition of graves and gravestones. Specimen trees located within the cemetery are in good condition. There are significant views to the church and steeple from various areas within the graveyard (Source: NBRSPARTNERS, October 2010)

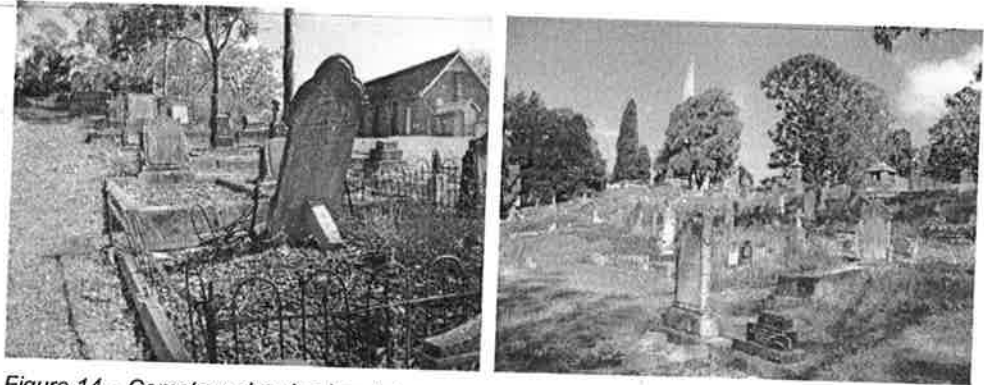
Figure 14 – Cemetery showing headstones, some headstones require rectification works. Views to the community hall (left) and Church steeple (right) are evident from within the cemetery (Source: NBRSPARTNERS, October 2010)

- **Policy 49:** *An arborist should be engaged to correct issue of destruction to the cemetery and monuments caused by falling tree limbs and tree roots.*

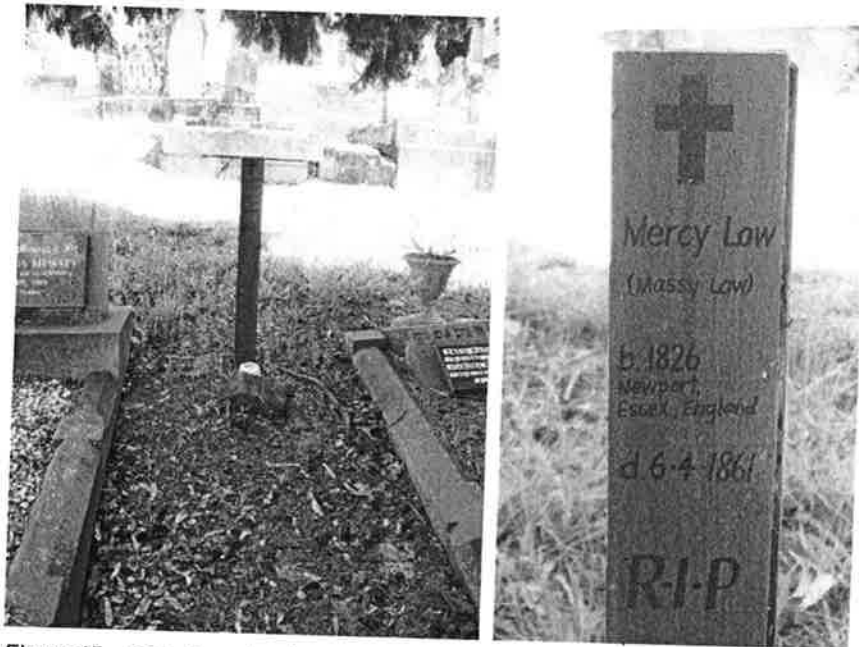
Figure 15 – Cemetery showing unmarked plot recently identified by relative who proposes a headstone be made for the grave site. This has raised issues as to the style of headstone to be used for a 19th century burial (Source: NBRSPARTNERS, October 2010)

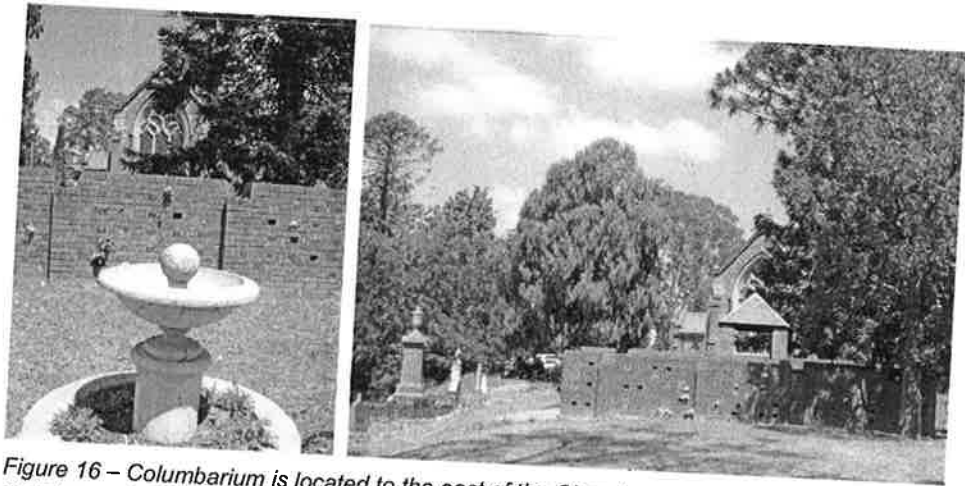
Figure 16 – Columbarium is located to the east of the Church, and north of the cemetery. It is necessary to extend the columbarium (Source: NBRSPARTNERS, October 2010)

- Accessibility issues are associated with some of the church buildings, in particular the Church, Rectory and Church Hall (1906).
- Sections of the cemetery are in poor condition and require maintenance, rebuilding and interpretation.
- There is a need to increase the number of memorial niches available in the existing Columbarium.

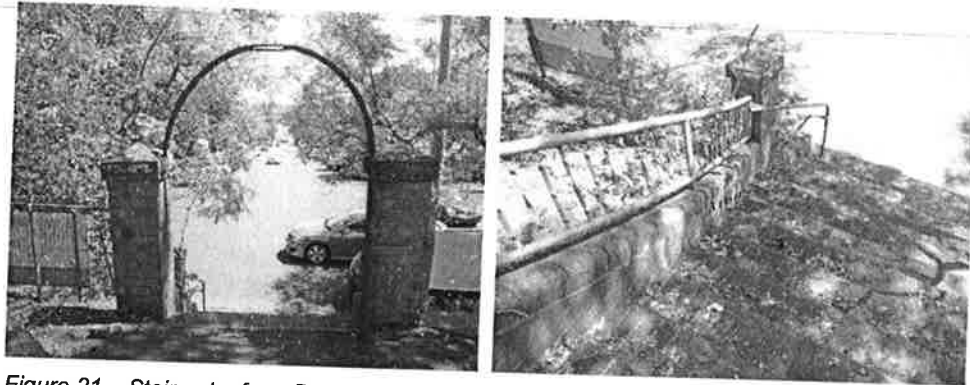
Figure 21 – Stair entry from Broughton Street with view north to John Street (left) and detail of steps and handrail (Source: NBRSPARTNERS, Oct 2010)

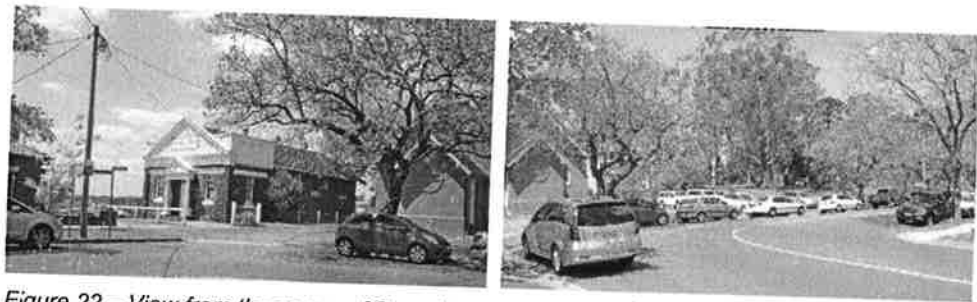
Figure 22 – View from the corner of Broughton and Hill Streets, looking east to Masonic Hall and the Church Hall (left), and southwest to the landscaped area between the two Community Halls (Source: NBRSPARTNERS, Oct 2010)

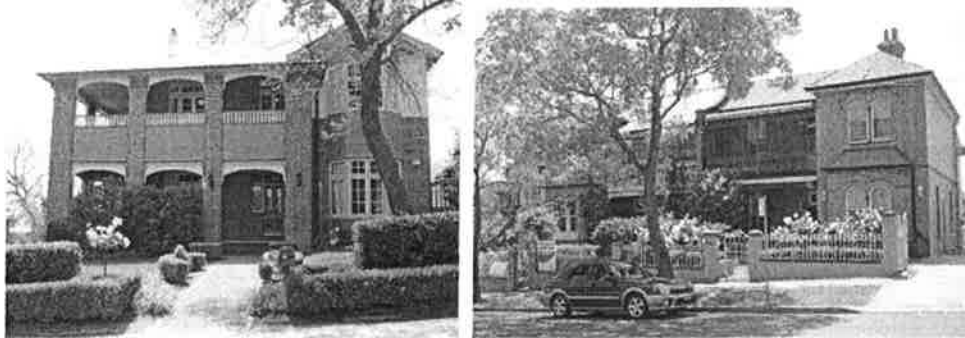
Figure 23 – No 28 Hill Street (left) and Nos 30 and 32 Hill Street (right), heritage items in close proximity to St John's Church and Grounds (Source: NBRSPARTNERS, Oct 2010)

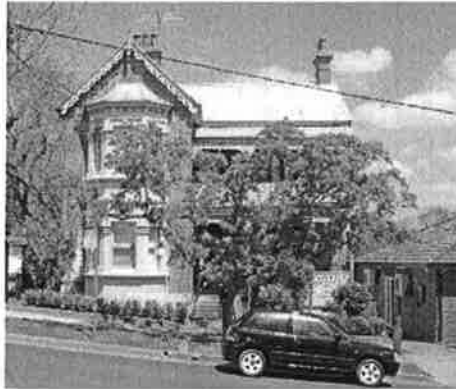
Figure 24 – No 33 Hill Street, heritage item in close proximity (Source: NBRSPARTNERS, Oct 2010)

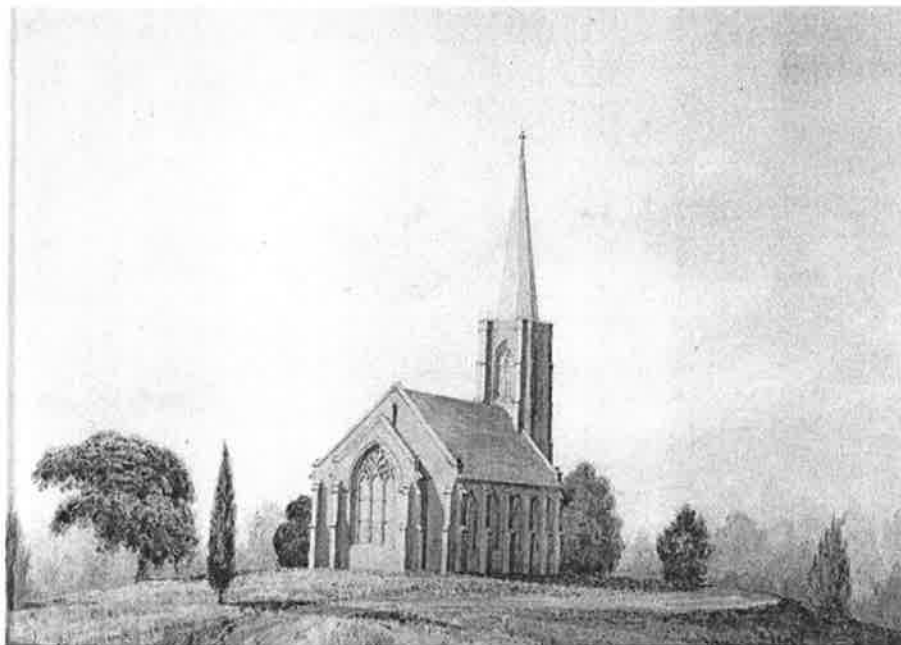
*Figure 25 – Unknown artist, St John the Evangelist, Camden, c1850 Watercolour and ink, showing the church before the chancel extension of 1873 (Source: Private collection –cited Joan Kerr and James Broadbent, *Gothick Taste in the Colony of NSW*, David Ell Press, Sydney, 1980, p113)*

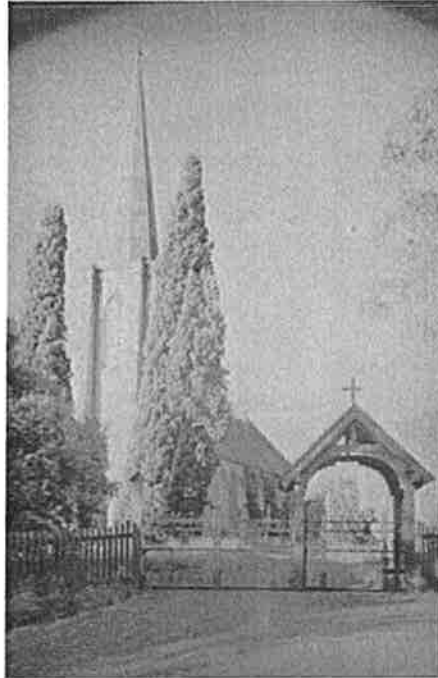
Figure 26 – St John's Church of England Camden, before erection of lych gate in 1912 date c1900 (left) and Eventide at St John's, Camden, 1941 showing lych gate (Source: Camden Historical Society (left) Wollongong Library (right))

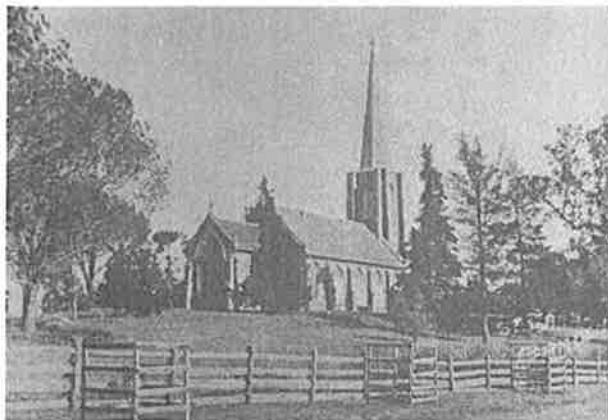
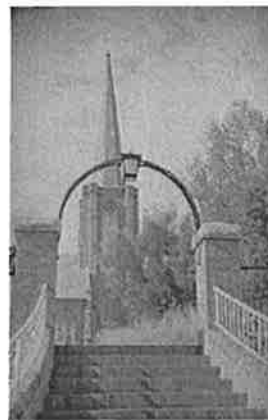
Figure 27 – View to St John's Church from Broughton Street, date unknown, showing the timber post and rail fence along Broughton Street and early street plantings (left) and St John's, Camden, 1941, showing stair entry from Broughton Street (Source: Camden Historical Society (left) Wollongong Library (right))
